### PHASE I REPORT NATIONAL DAM SAFETY PROGRAM TENNESSEE

Name of Dam	Red Boiling Springs Dam No. 1
County	Macon
Stream Tributary of Sal	t Lick Creek at Witcher Hollow
Date of Inspection	January 8, 1981
	luation was prepared by the nservation, Division of Water
PREPARED BY:	William Culbert, Jr. Water Resources Engineer
APPROVED BY:	Edmond O'Neill Chief Engineer Safe Dams Section

PHASE I INSPECTION REPORT NATIONAL DAM SAFETY PROGRAM RED BOILING SPRINGS DAM NO. 1 MACON COUNTY, TENNESSEE

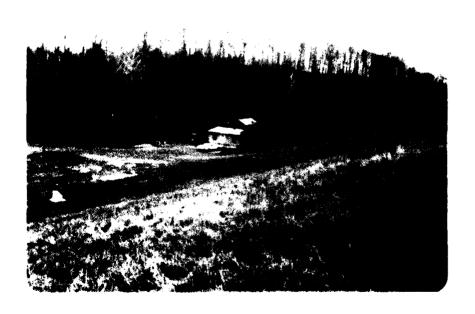
PHOTO NO.15

lies on a moderate 1.2 - 1.5% slope and has gently sloping sides. There is only scant vegetative cover, but no significant erosion was observed. Apparently only nominal flow has been carried by the channel in recent years (see photo nos. 16 & 17).
